# Manhole Inspection Summary

Manhole # S17I\_\_022MH

Insp Date: **2/27/08 9:25 AM**

**Location** Address: **2 willard st**

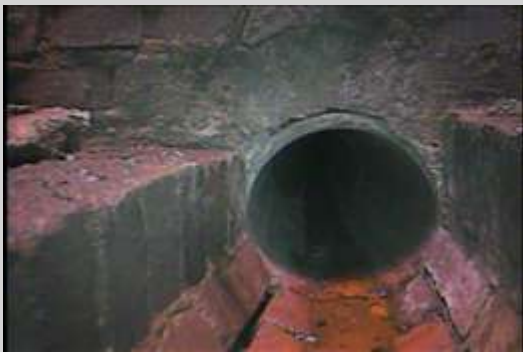
12 O'Clock Outflow

8 in. Circular Gravity Sewer  
Pipe Out @ 12 O'Clock

Pipe Height: **8.4** (in.) Rod and Bar (Angled)  
Pipe Material: **Clay** ☐ Pipe Lined  
Invert Depth: **8.10** (ft.) Flow Characteristics: **Slow**  
Deposits: ☒ None ☐ Mud ☐ Sludge ☐ Debris ☐ Grease  
Silt Depth: **0** (in.) Deposits Extent:  
Infiltration: **None** Pipe Seal Cond: **Sound**
